Full Length Research Paper

Petrographic identification and physical behavior of building materials in the archeological site of "Banasa" (Morocco)

The archaeological site of "Banasa" is a historical heritage which is an asset of cultural tourism in the region of Gharb (Morocco). A petrographic characterization was carried out for the building materials of the site, and for the lithofacies which resemble to those of "Banasa" and come from geological formations close to the site. Comparison of the results allowed us to identify the different lithofacies of the site, found in majority to be sedimentary rocks, originated from well known geological formations of which we have determined the locations in this study. The three most abundant lithofacies are i) calcarénites from Bouknadel, ii) Biocalcarenites from Lalla Zahra, and iii) quaternary sandstone from the Gharb. A study of the physical behavior (density, porosity, water absorption, permeability and resistance to salt crystallization) of these three most abundant lithofacies was performed. The results showed that the calcarénites and the Biocalcarenites hold more porosity (respectively 16.76% and 14.87%) than the sandstones (8.82

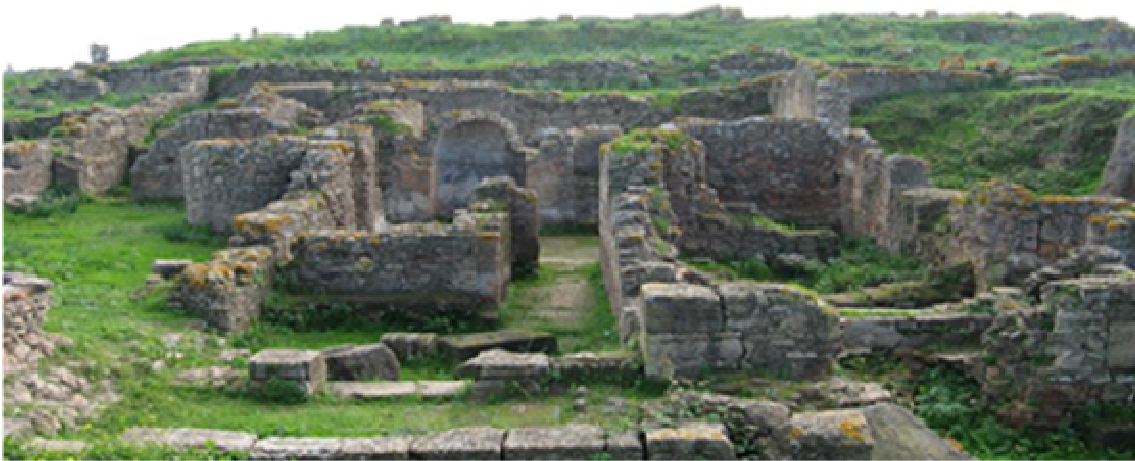
Figure 1. The archeological site of "Banasa", the thermal buildings.

The two first lithofacies (E1 and E2) have been widely used in the construction, for instance in the Forum and houses, while the sandstones (E3) have been used in the construction of thermal buildings (Figure. 1).

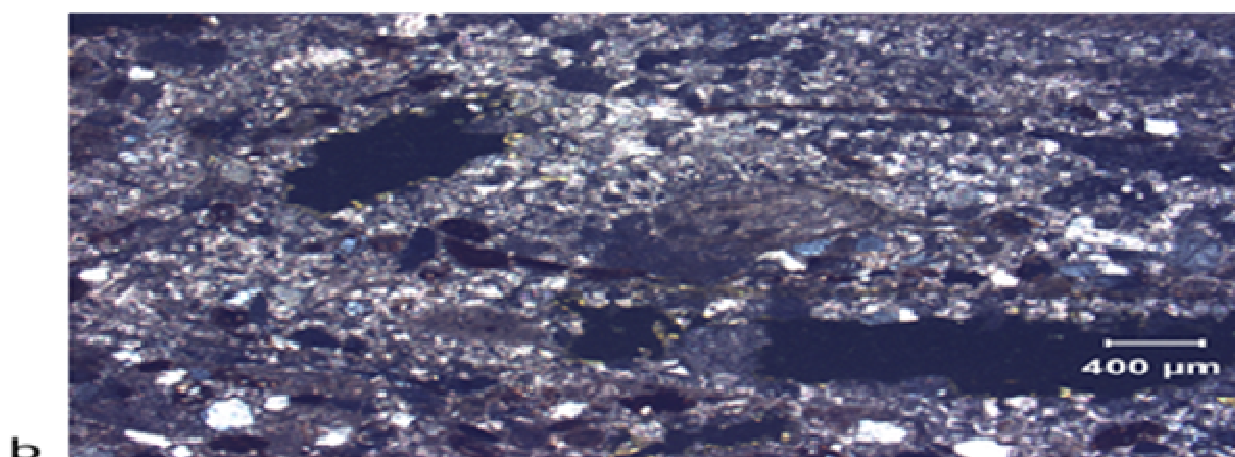
Figure 3. Photomicrographs of the samples from "Banasa" (observation in polarized-analyzed light). a) lithofacies E1, b) lithofacies E2, c) lithofacies E3.

- Calcarénites (E1) beige-gray, rich in grains of quartz and fragments of rocks and shells (Figure 3a) were compared with samples from the quarries of Bouknadel (C1) Plio-Quaternary age, and with samples from Ben Slimane (C2) Pliocene age. According to the petrographic analysis, the sample (E1) was found very similar to the lithofacies of Bouknadel (Atlantic coast).

- Biocalcarenes (E2) beige-yellow, very rich in fossils and rocks fragments (Figure 3b), were compared with samples of Lalla Zahra (C3) Neogene age, and samples of the quarries of Hssinate (C4) (Moulay Bousham). The results showed that (E2) are identical to those of Lalla Zahra (C3).

- Sandstones (E3) rich in fragment of rocks (Figure 3c), were found to be similar to the samples of the quaternary sandstone (C5) that outcrop at the top of the Gharb Pliocene.
